**CAPE COD CANAL  
BOURNE, MASSACHUSETTS**

# **BOURNE HIGHWAY BRIDGE MAJOR REHABILITATION**

## **DESIGN MEMORANDUM**

**NOVEMBER 1963**

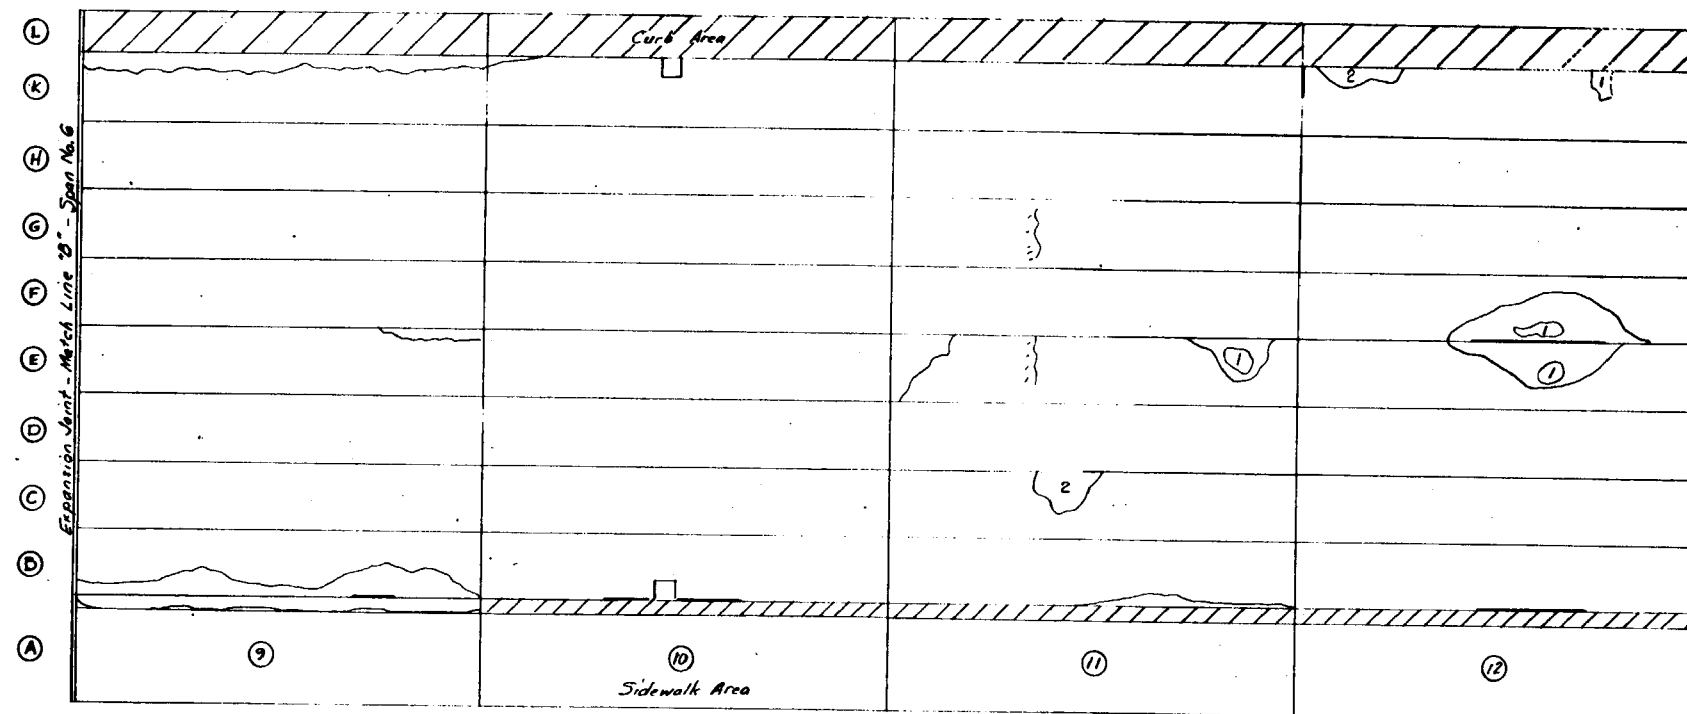
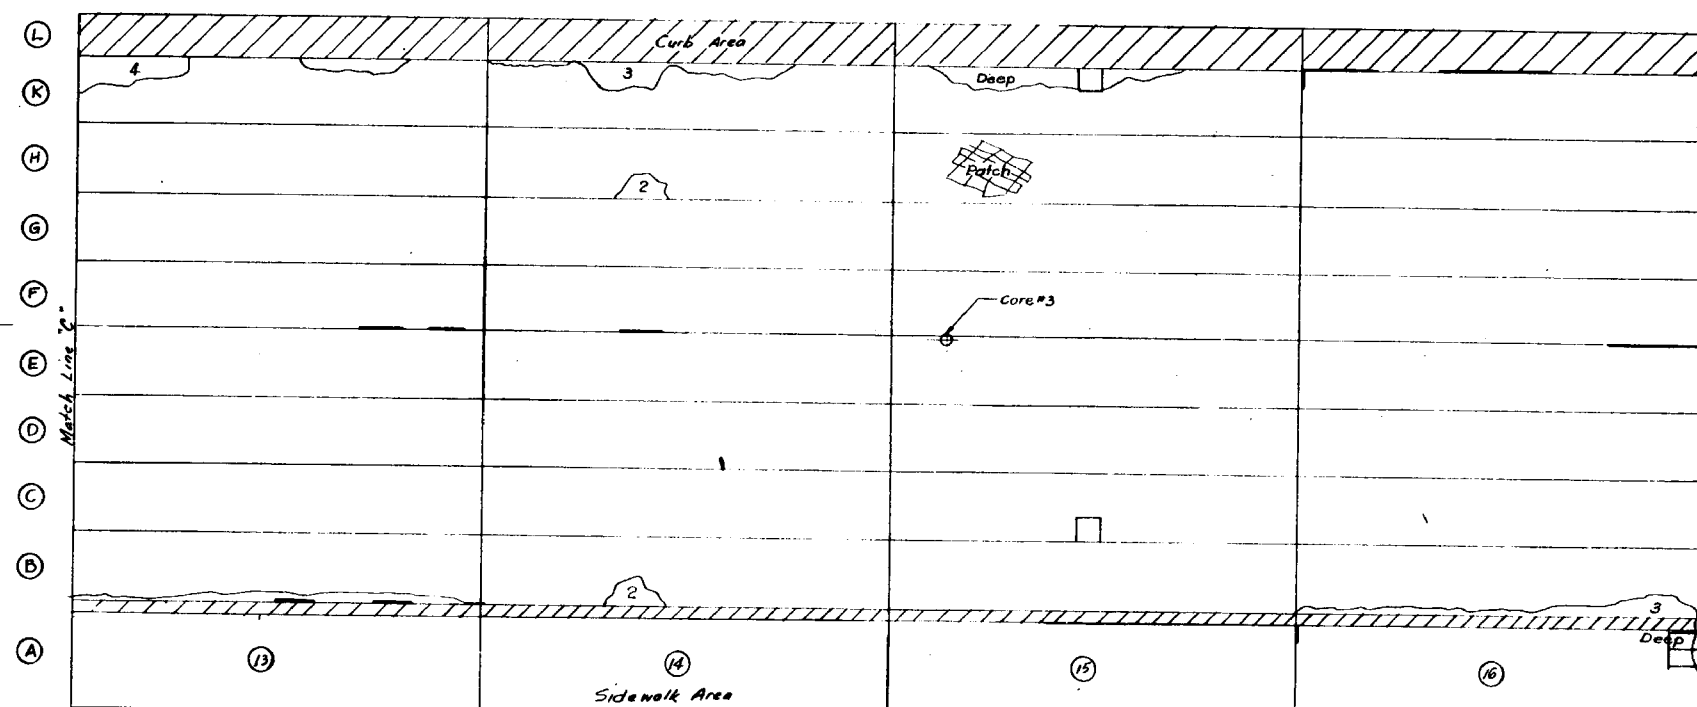
**CAPE COD CANAL**  
 BOURNE, MASSACHUSETTS  
 CONDITION SURVEY  
 BOURNE HIGHWAY BRIDGE  
 SPAN NO. 4  
 1962-1963

5th Joint - Expansion. - At Pier No. 6 and at the beginning of Span No. 4. The plate is 18 inches wide and in two pieces. The plates are loose and the support plate beneath the cover plate has settled such that point bearing exists between the two surfaces. Steel shows leakage occurs and rusting is moderate in particular on the transverse girder.

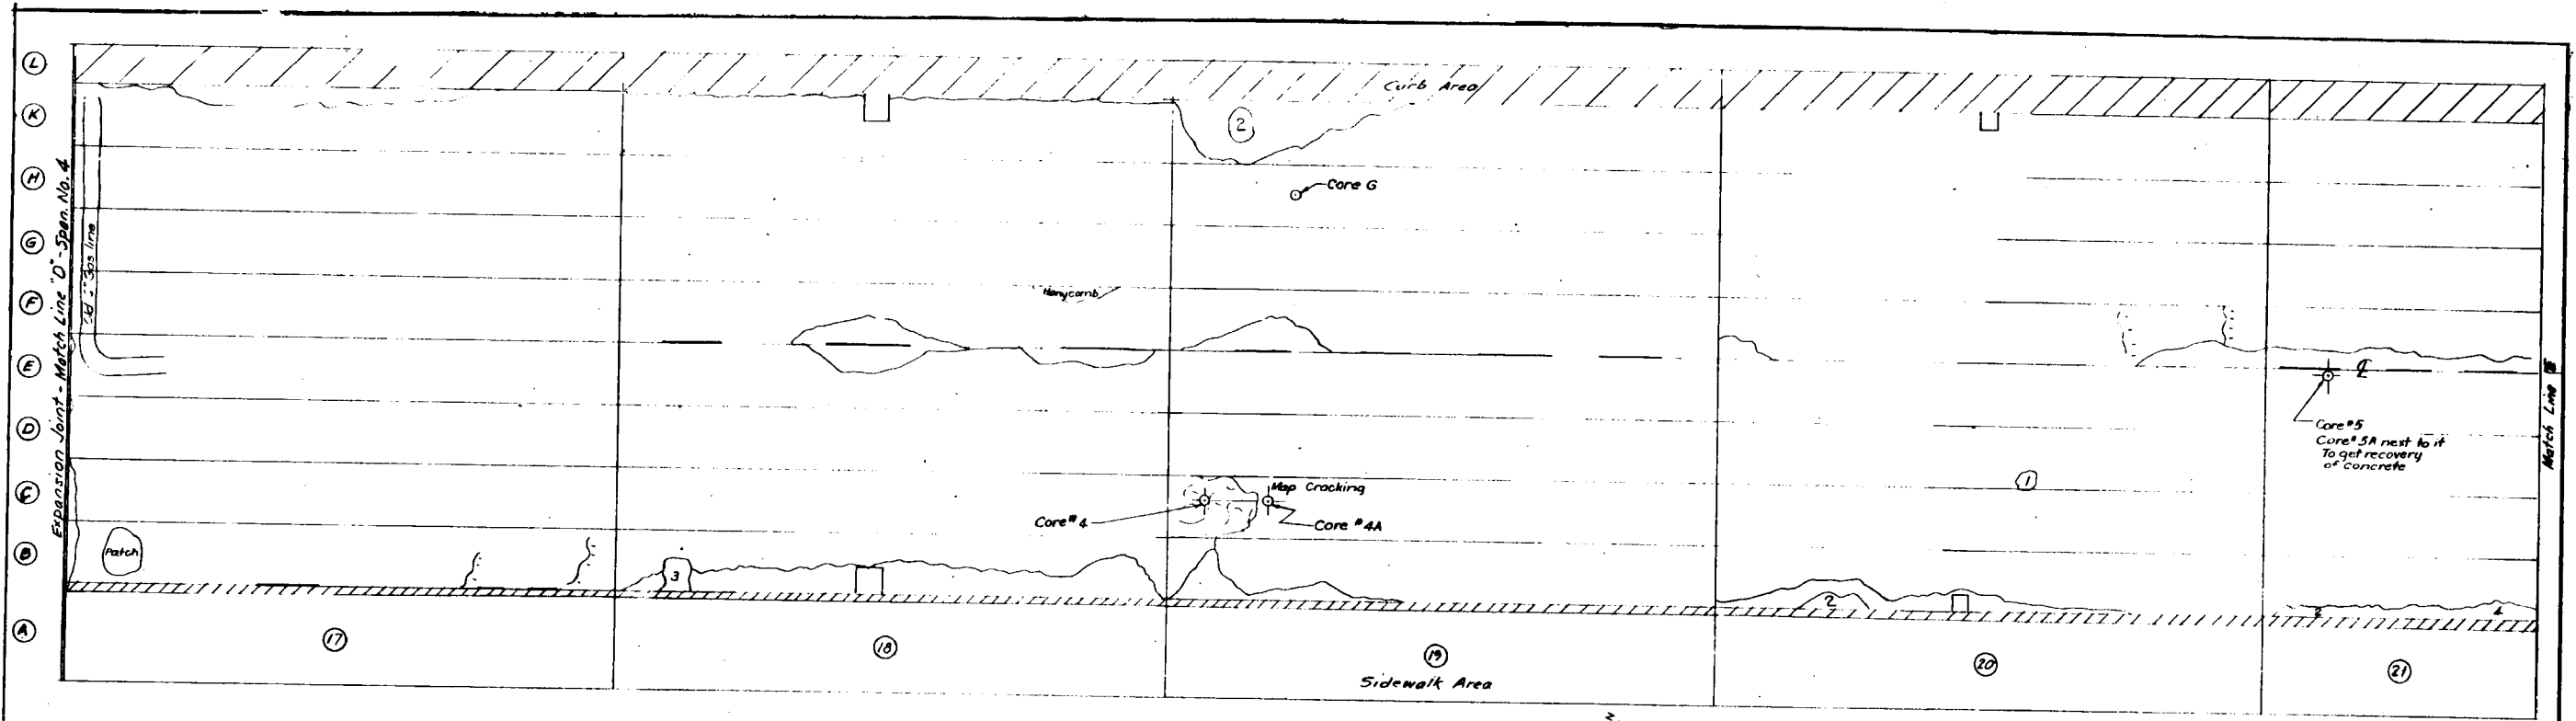
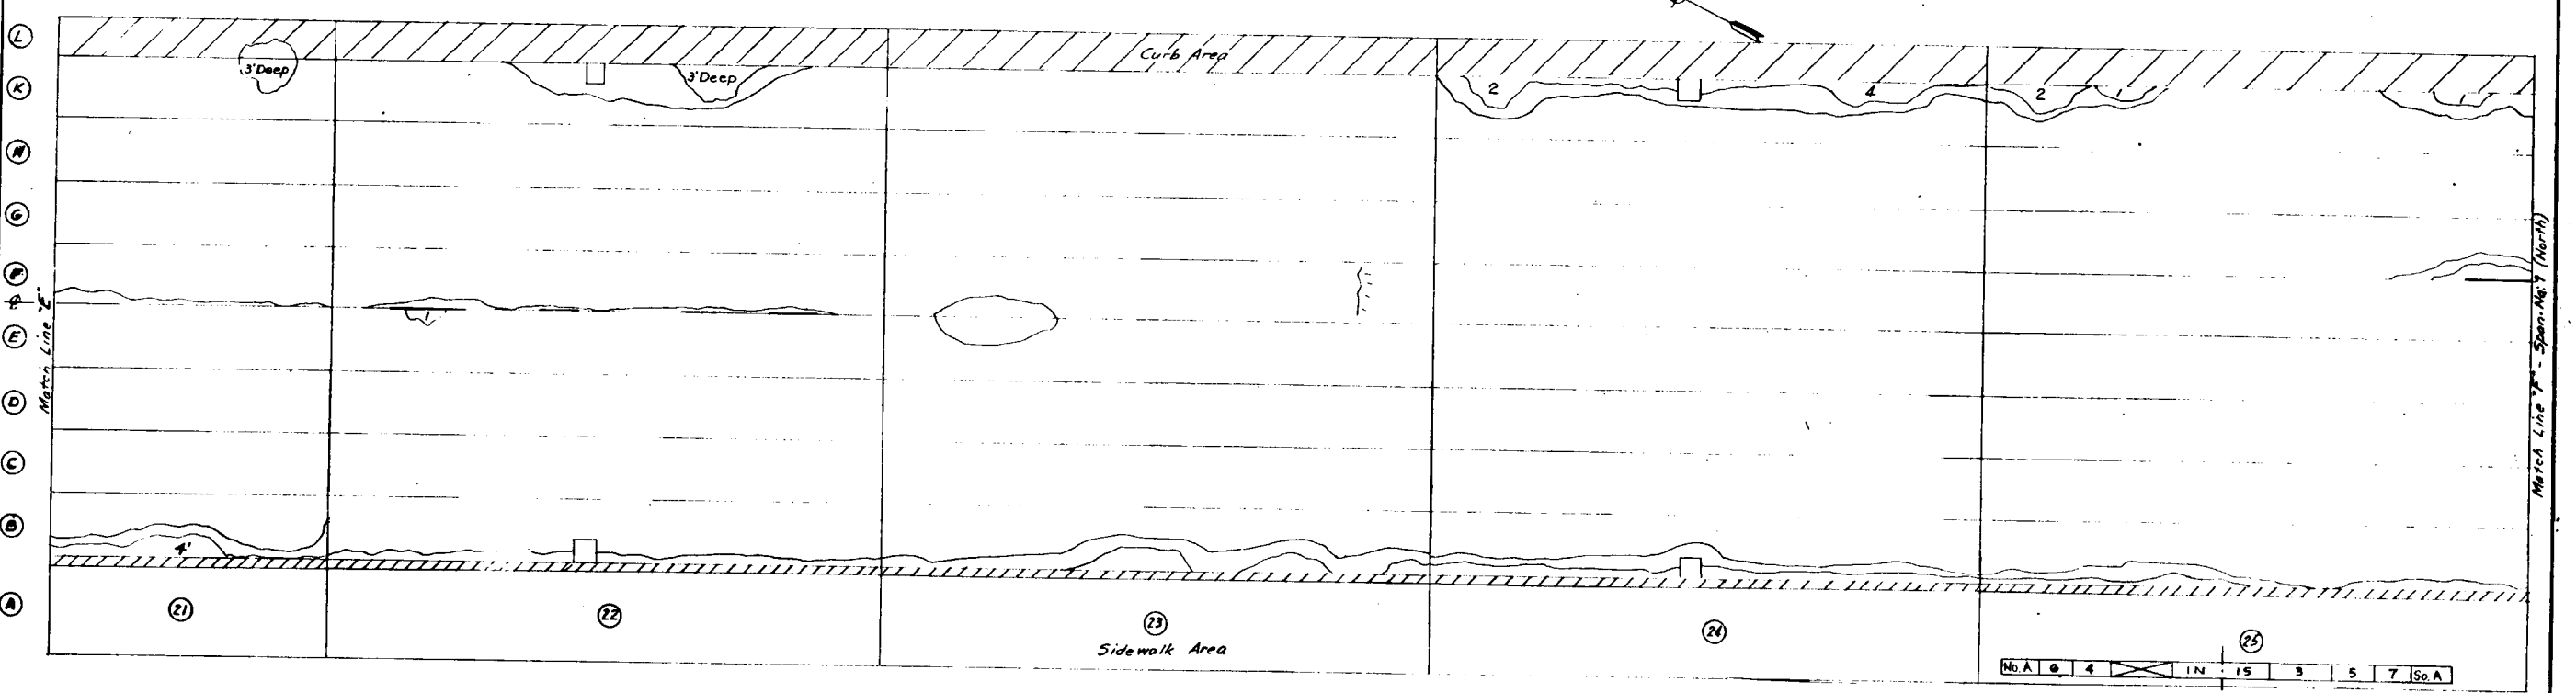
CAPE COD CANAL  
 BOURNE, MASSACHUSETTS  
 CONDITION SURVEY  
 BOURNE HIGHWAY BRIDGE  
 SPAN NO. 2  
 1962-1963

6th Joint - Expansion. - At Pier No. 4 and at the beginning of Span No. 2. The joint cover plate is 6 feet wide and in four pieces. On the east side, the plate is loose and causes a thumping effect. The structural steel is rusted severely and an area exists where no paint has been applied. A number of rivets have rusted to such a point that replacement is essential. The finger plates and the transverse girder are heavily rusted.

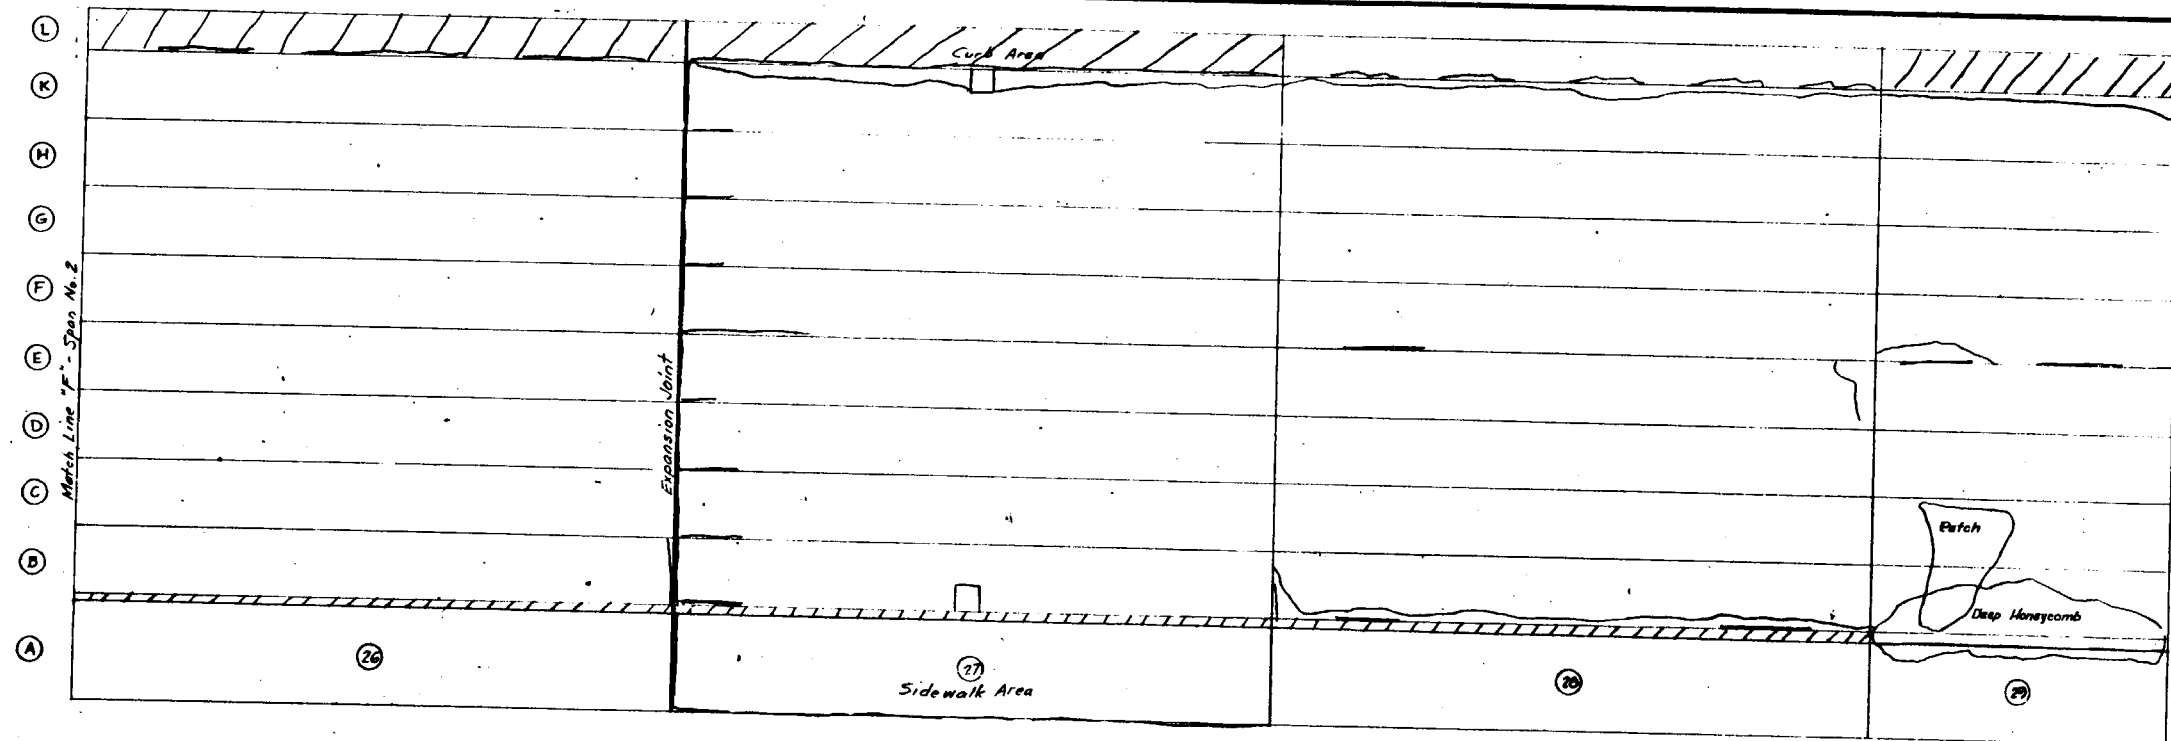
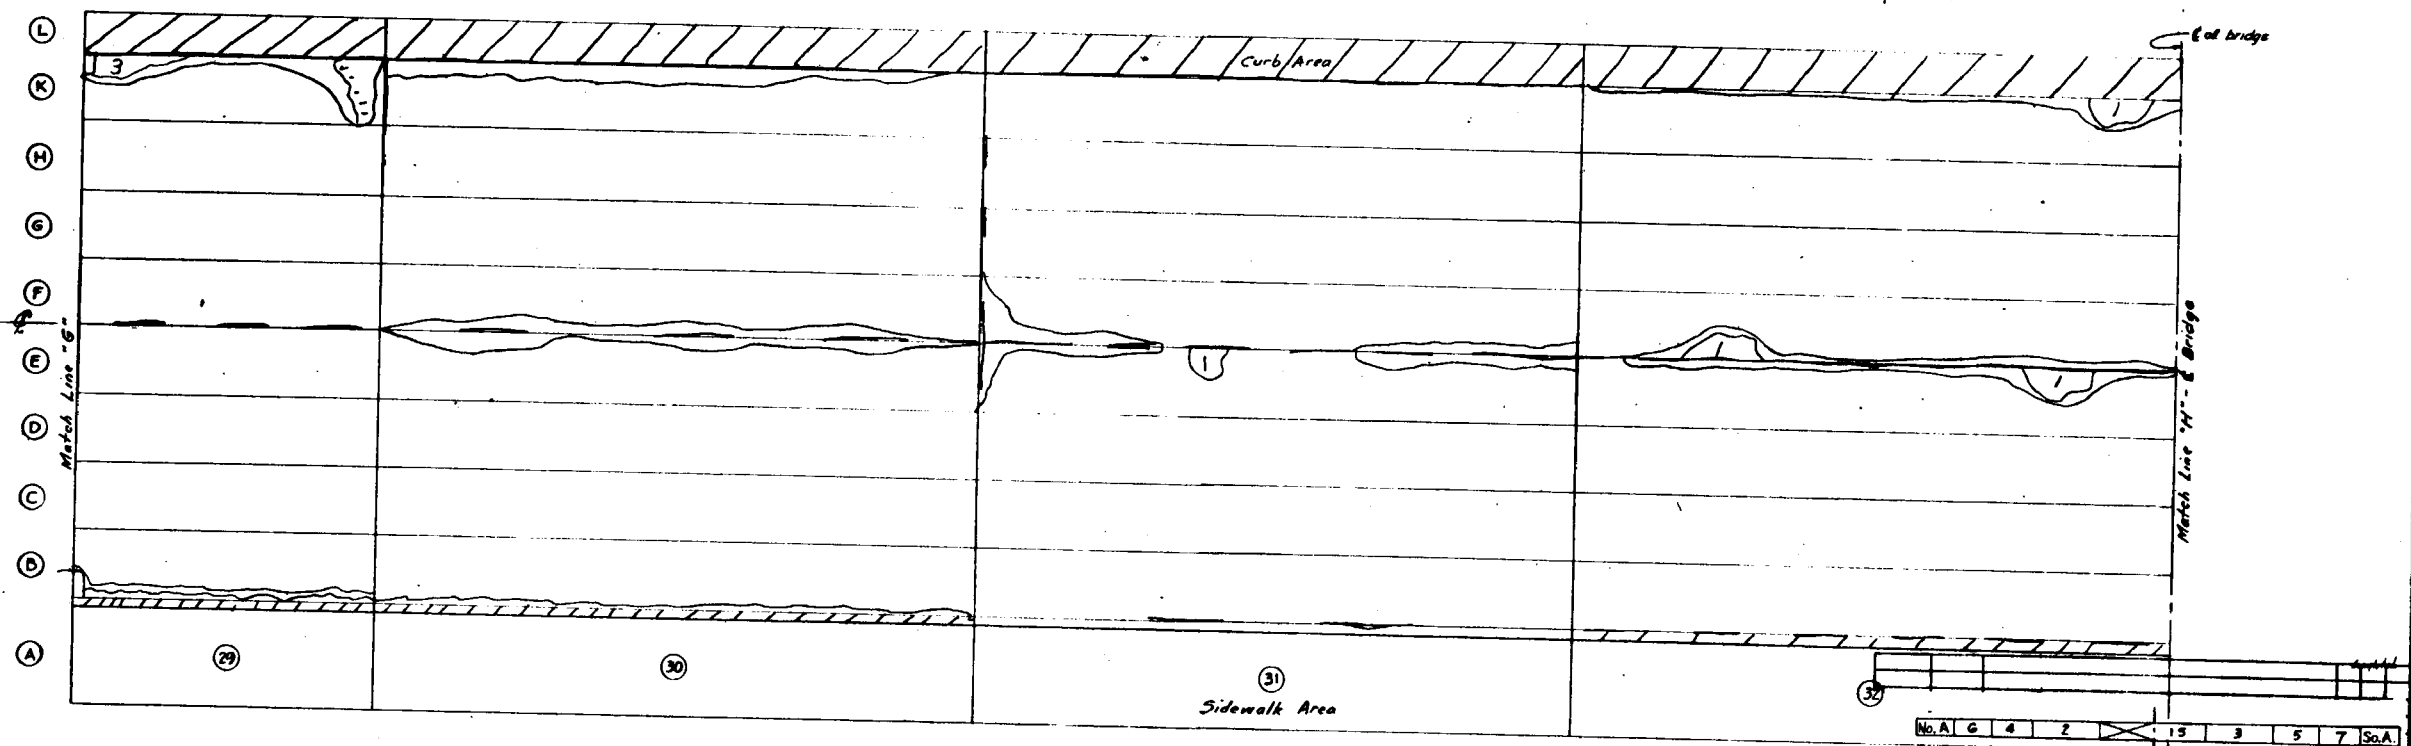
CAPE COD CANAL  
BOURNE, MASSACHUSETTS  
CONDITION SURVEY  
BOURNE HIGHWAY BRIDGE  
SPAN NO. 1-NORTH  
1962-1963

7th Joint - Expansion. - Close to Pier No. 2 and at the beginning of Span No. 1. The joint has a 15-inch cover plate. The amount of expansion possible is small (less than 1/2 inch). The structural framing is heavily rusted. The concrete is deteriorated on each side of the joint and must be replaced.

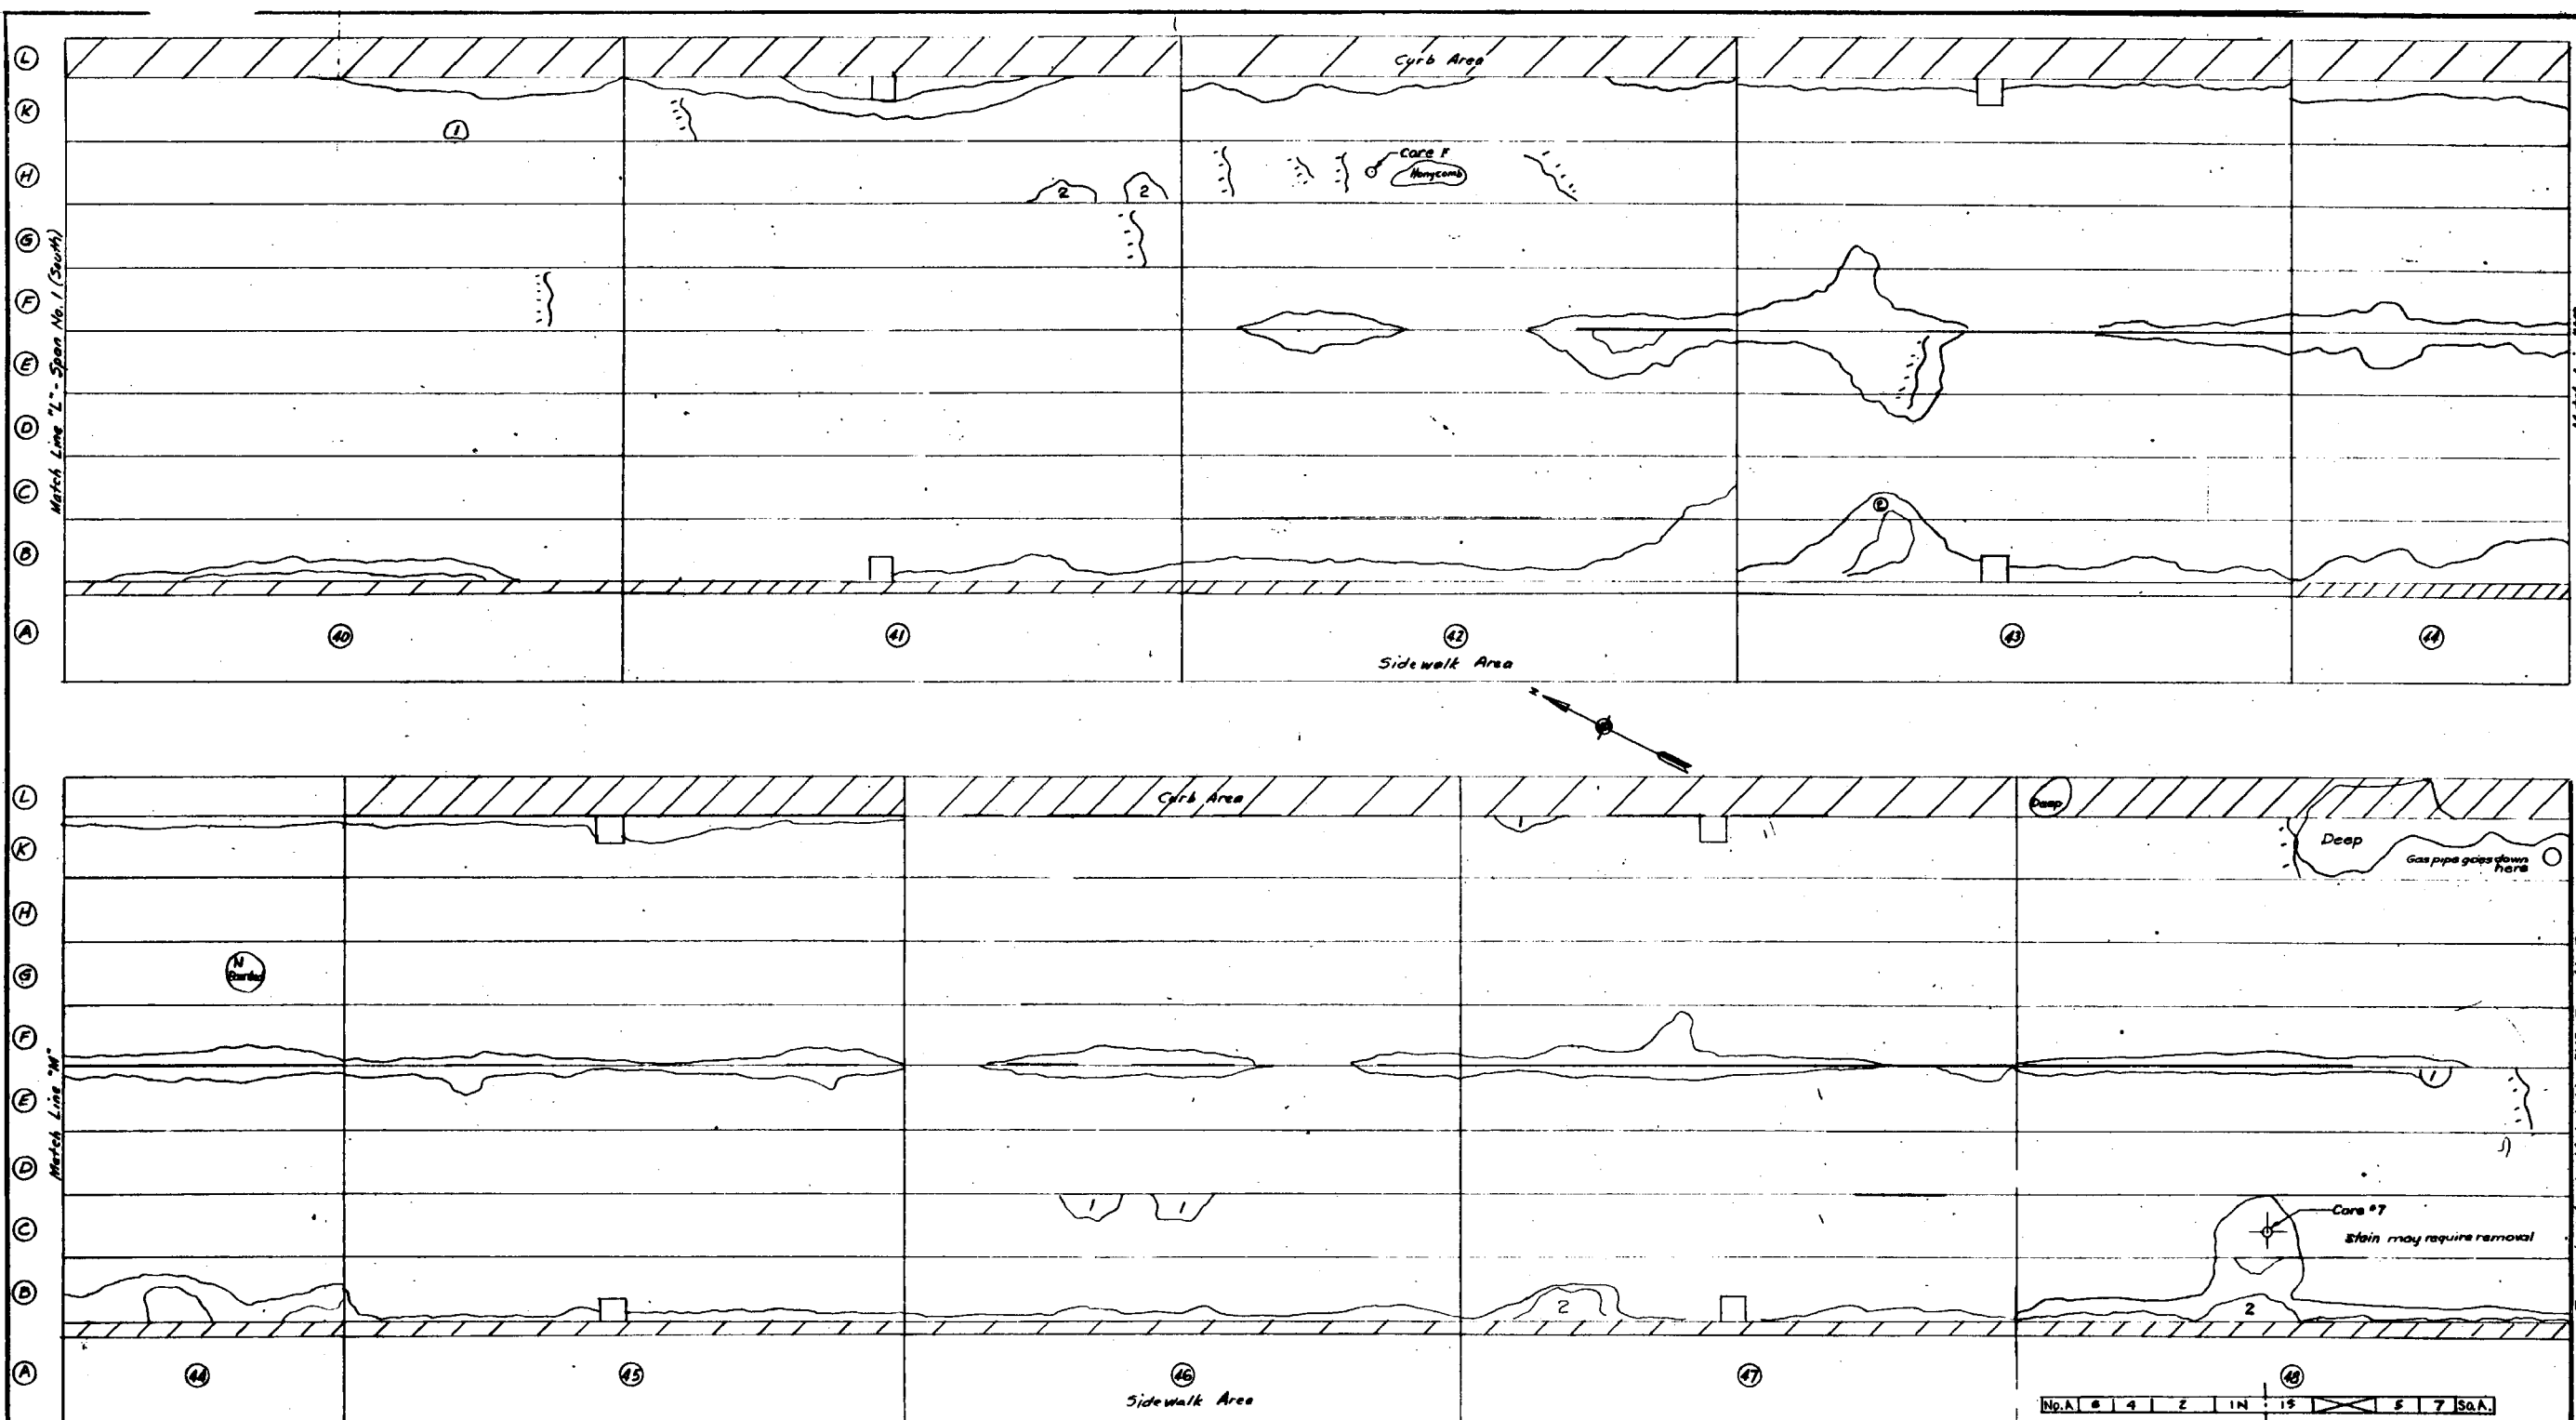
**CAPE COD CANAL**  
 BOURNE, MASSACHUSETTS  
 CONDITION SURVEY  
 BOURNE HIGHWAY BRIDGE  
 SPAN NO. 3  
 1962-1963

8th Joint - Expansion. - Close to Pier No. 1 and at the beginning of Span No. 3. The joint has a 15-inch cover plate that is in relatively good condition although slight thumping occurs on the east side. The structural framing is moderately rusted on each side of the joint for the full length of the joint.

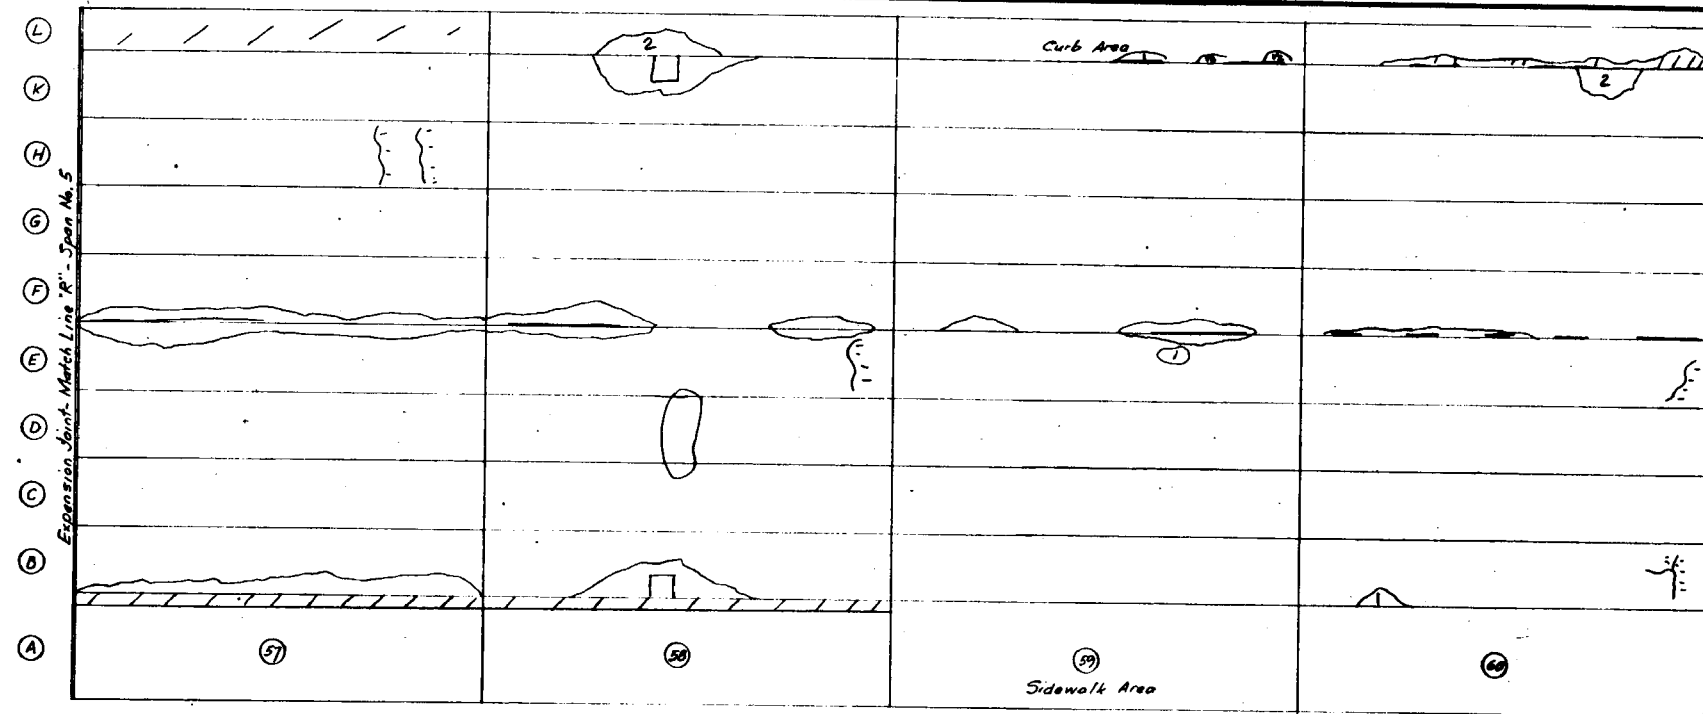
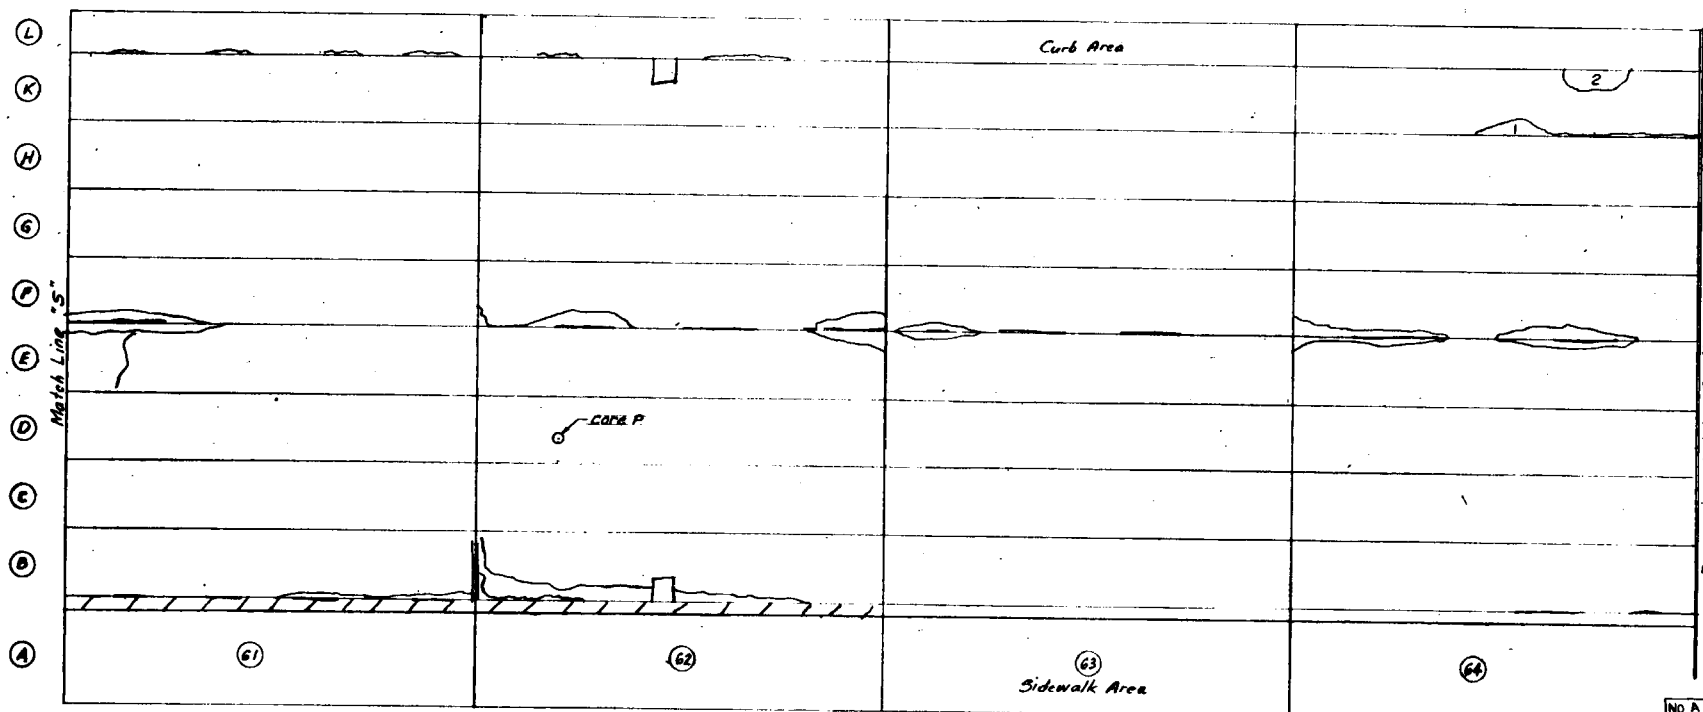
**CAPE COD CANAL**  
BOURNE, MASSACHUSETTS  
**CONDITION SURVEY**  
**BOURNE HIGHWAY BRIDGE**  
**SPAN NO. 7**  
**1962-1963**

10th Joint - Expansion. - At Pier No. 5 and at the beginning of Span No. 7. The 15-inch cover plate is loose and creates vibration. The plate is cut in several pieces and needs to be replaced. The 3-1/2 inch angle nosing on the east curb is in poor condition. The structural steel has a little rust, but is in good condition.

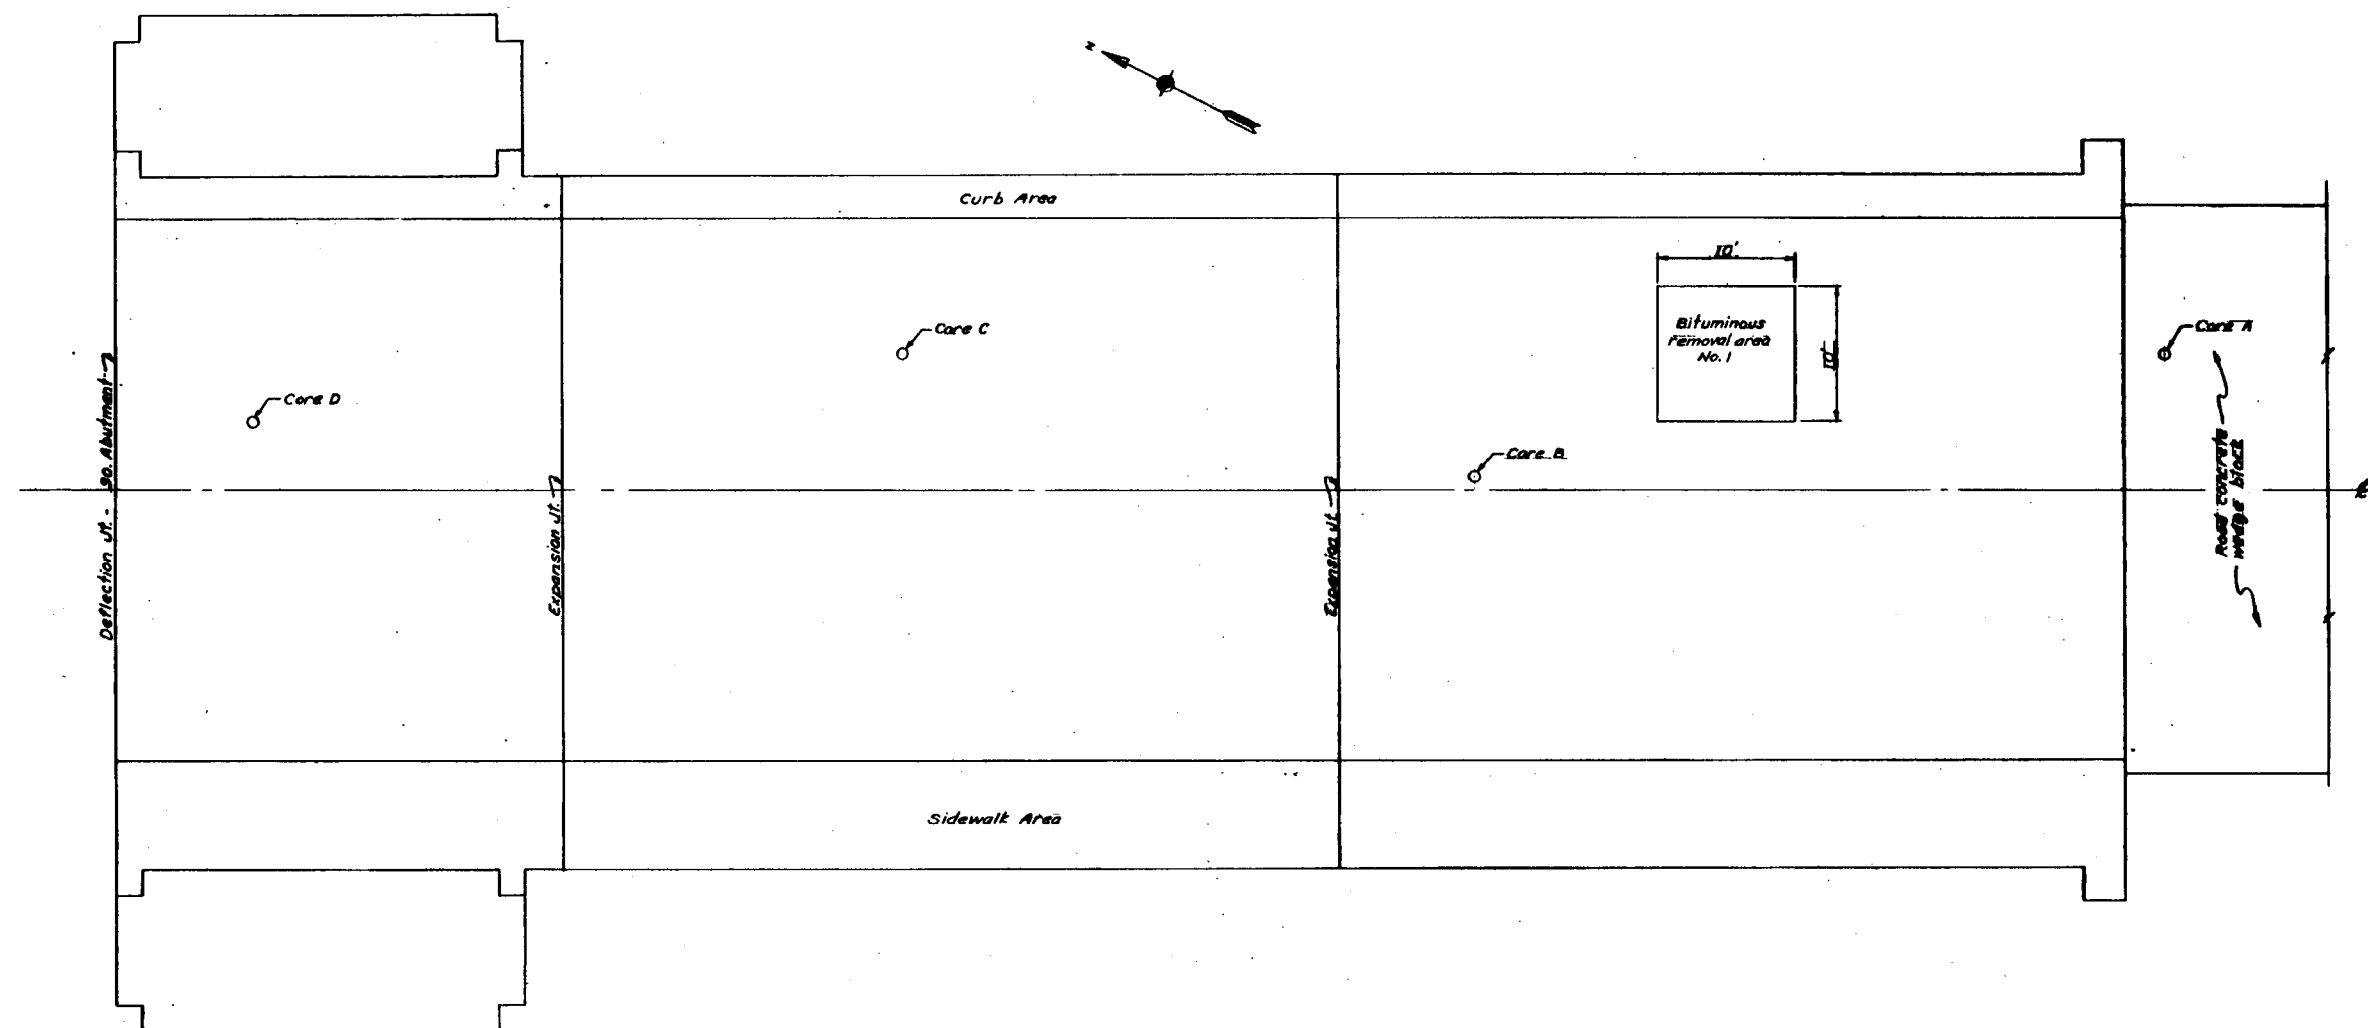
CAPE COD CANAL  
BOURNE, MASSACHUSETTS  
CONDITION SURVEY  
BOURNE HIGHWAY BRIDGE  
SOUTH ABUTMENT  
1962-1963

11th Joint - Deflection. - At the beginning of the South Abutment. The cover plate and its rivets are loose. The plate is cut in several pieces and has settled below the roadway surface. When a heavy vehicle strikes the joint, the bridge vibrates. The joint needs to be replaced. Evidence of seepage is visible, but rust in the vicinity of the joint is light.

12th Joint - Expansion. - Located 33 feet from the 11th joint. The cover plate is in poor condition. The plate is split in several pieces and the rivets are loose.

13th Joint - Expansion. - Located 57 feet from the 12th joint. The cover plate has settled so that the transition across the joint is irregular and causes the blades of the snow plows to strike the joint. The joint otherwise is in good condition.

14th Joint - Angle Nosing. - South Abutment at transition block. The nosing is in good condition and no repair work is required.
